# Streambank erosion repair

## Case study: Streambank erosion repair in the Laidley Creek

This case study outlines the steps taken in restoration activities in Laidley Creek after the 2011 and 2013 flood events. This is a complex example involving a number of stages to address multiple threatening processes occurring simultaneously.

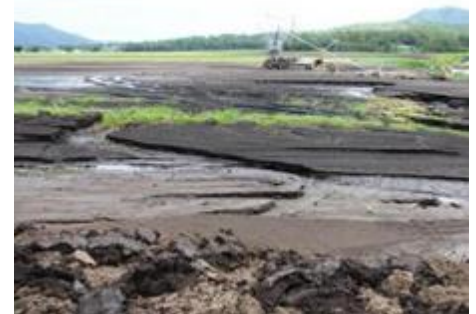
Soil cover in the form of mature crops can minimise topsoil loss and reduce impacts on farm productivity.

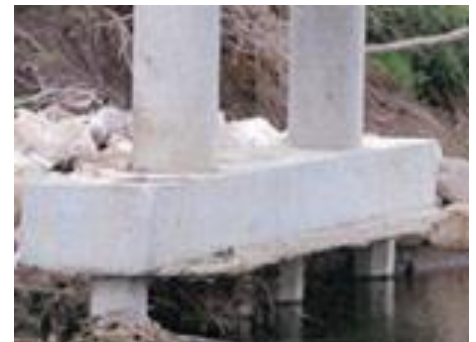
Streambed lowering impacts on structural integrity of man-made assets as well as the stability of streambanks.

Critically, the creek bed suffered from erosion and lowered in response to the flood. Bed lowering affects not only infrastructure such as the foundation of bridges, but also the stability of the streambanks as they typically widen in response to bed lowering.

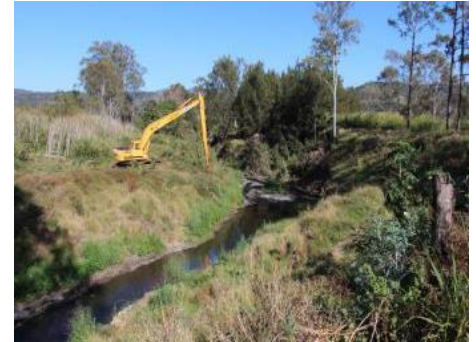
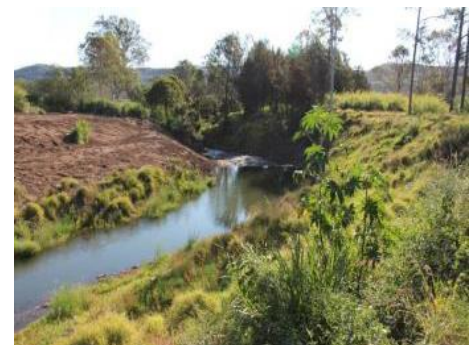
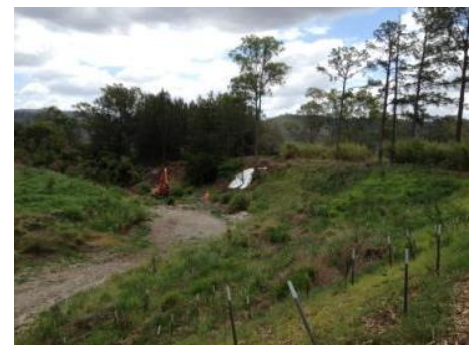
Photo points have been taken to build a picture of progress over time from before the start of works and will continue into the future.

At least quarterly inspections have been conducted since works completion and more frequently after rainfall events in early 2015.
